**PROJECT REPORT**

**RANGE CLEANUP – WI042, 88<sup>th</sup> RSC  
MILWAUKEE (LOGAN)  
U.S. ARMY RESERVE CENTER  
MILWAUKEE, WISCONSIN**

**Contract No. DACA 27-99-D-0021  
Delivery Order No. 0014**

**February 2003**

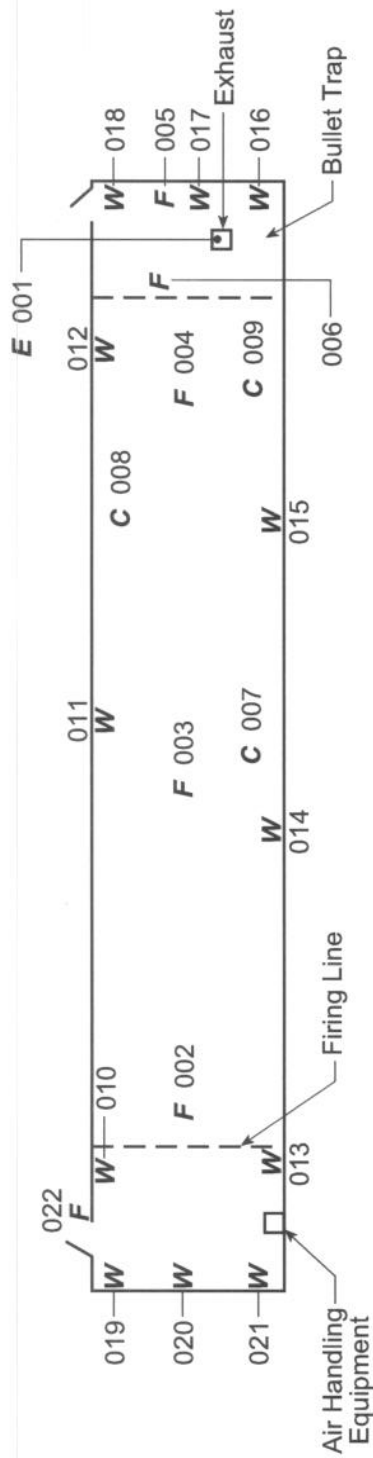
Figure 3-1.  
 Clearance Wipe Sample Locations.  
 Milwaukee, WI (WI042) Reserve Center.

Figure 3-1 shows the locations where clearance samples were collected. Sampling procedures are discussed in Section 4.1; analytical results are presented on Table 4-1. The clearance inspection and dust wipe sample collection forms and the analytical report are included in Appendices C.

- After cleaning, the range had lead levels from <2.5 µg/sf (ceiling and wall samples) to 190 µg/sf (mid-range).
- The floor outside the entrance door had a lead level of 36 µg/sf.

Thus, based on these results, the clearance criteria of 200 µg/sf had been attained.
